**US Army Corps
of Engineers
Baltimore District**

**NATIONAL HISTORIC CONTEXT FOR
DEPARTMENT OF DEFENSE INSTALLATIONS, 1790 - 1940**

Volume II of IV

FINAL REPORT

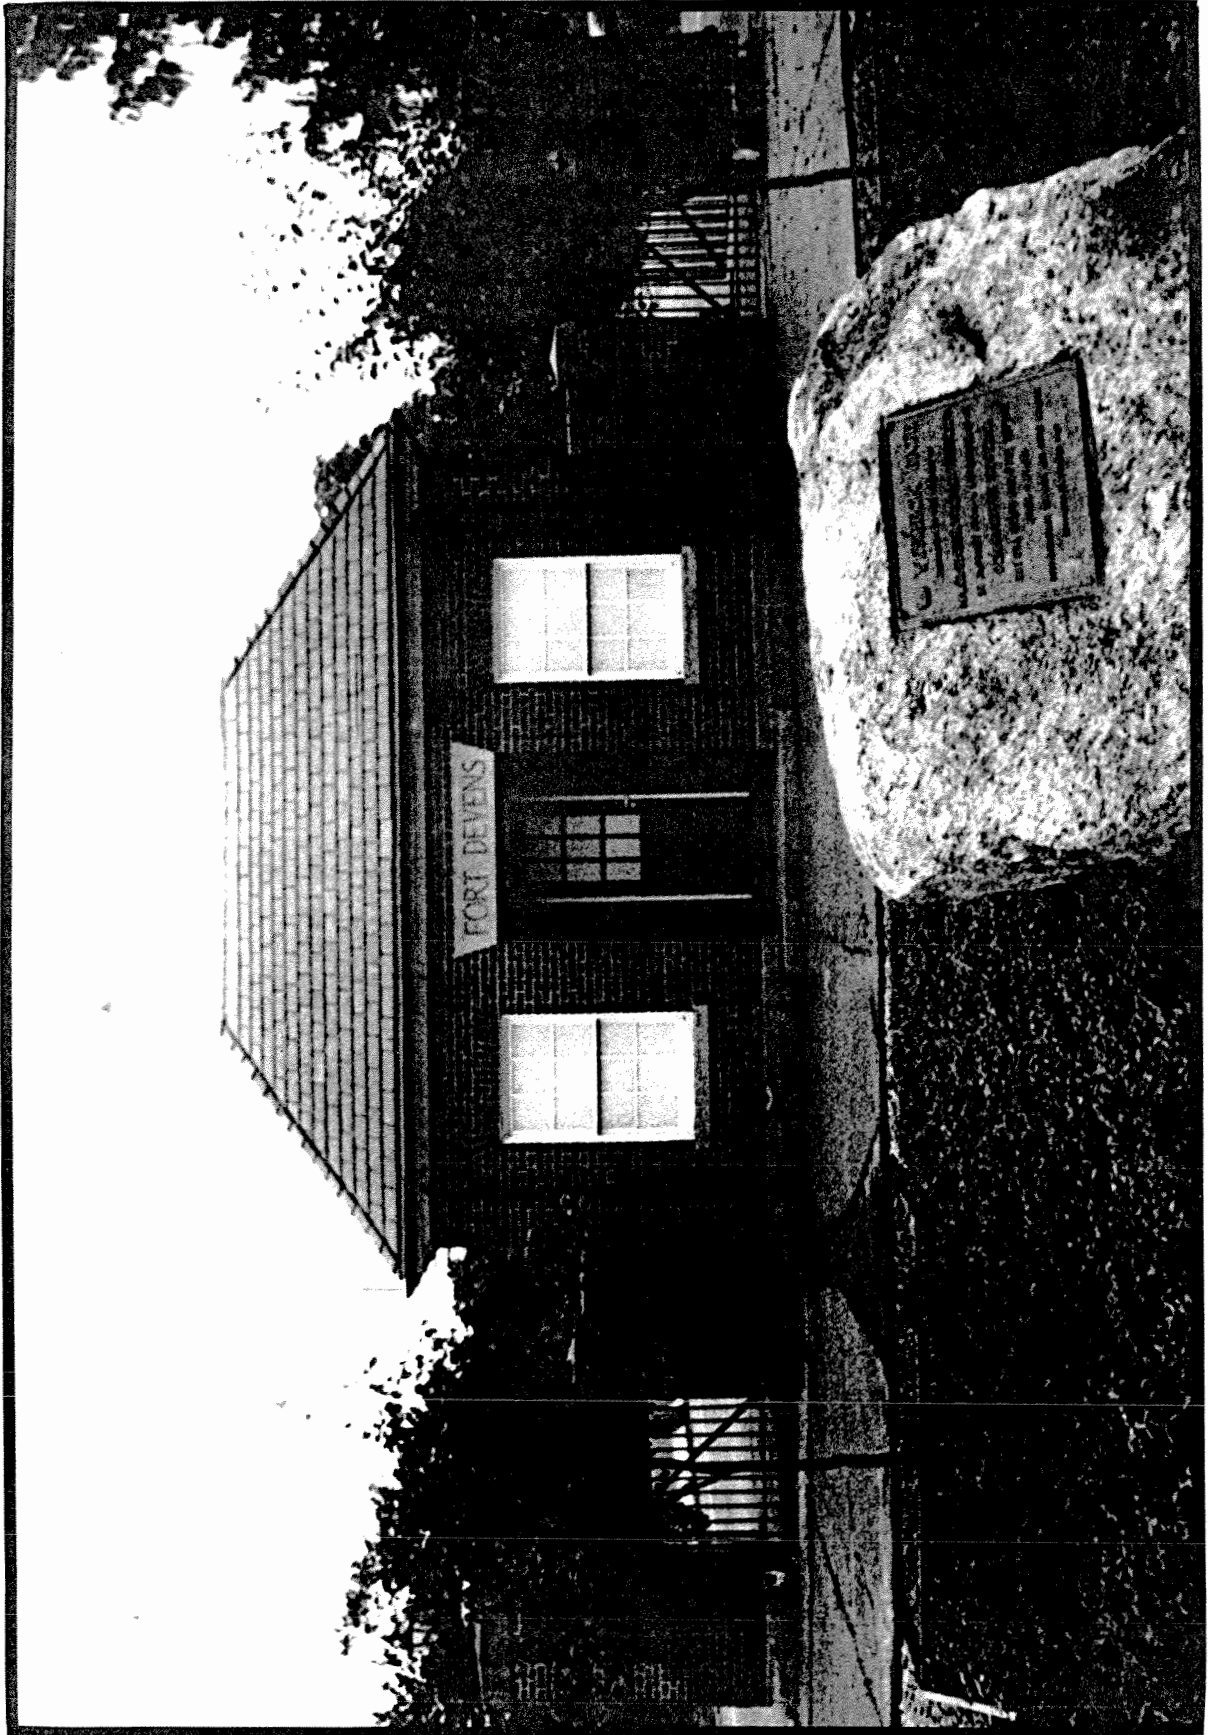
Figure III-6. 1909 Guardhouse, Quartermaster standardized plan no. 206 (Building 234, F.E. Warren AFB, [formerly Ft. D.A. Russell], Wyoming), *above*. 1932 French Colonial Revival combined fire station and guardhouse (Building 5676, Barksdale AFB, Louisiana), *below*

At the beginning of the twentieth century, the guardhouse retained the same basic shape as those of earlier times, but Colonial Revival details replaced the earlier Victorian-era details (Figure III-6). In general, the size of the building increased as the sizes of individual installations increased.⁶

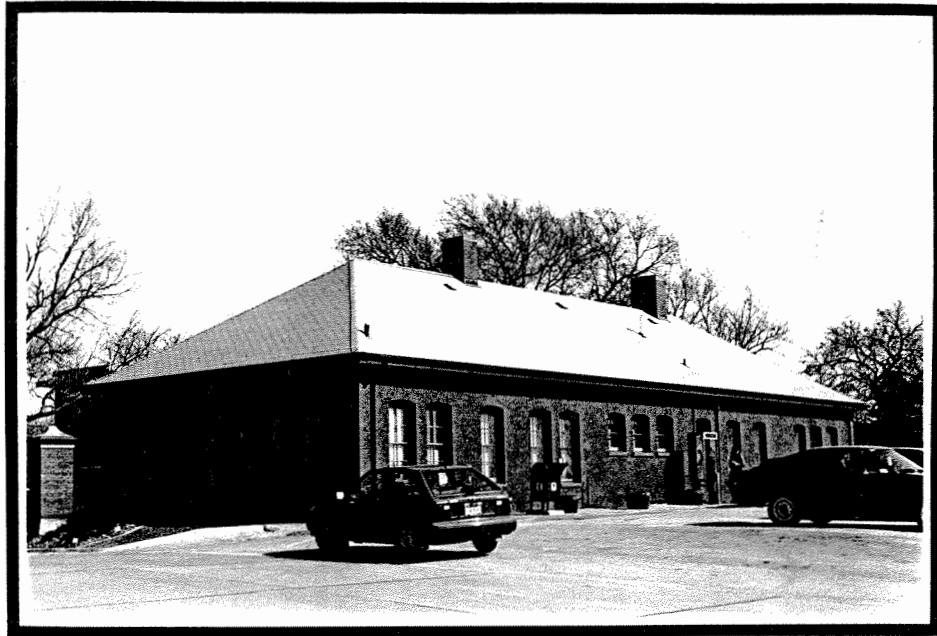
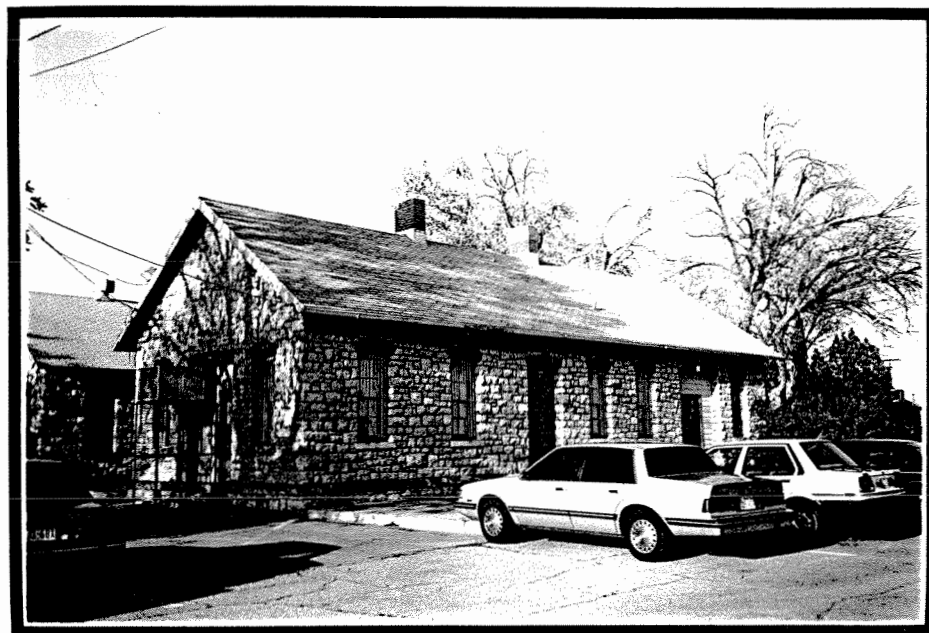
Figure III-49. Quartermaster shop constructed in 1893 to house blacksmith, tinsmith, plumber, paint, carpenter, and wheelwright shops (Building 44, Offutt AFB [formerly Ft. Crook], Nebraska), *above*. 1895 Quartermaster shop (Building 2009, Ft. Bliss, Texas), *below*.

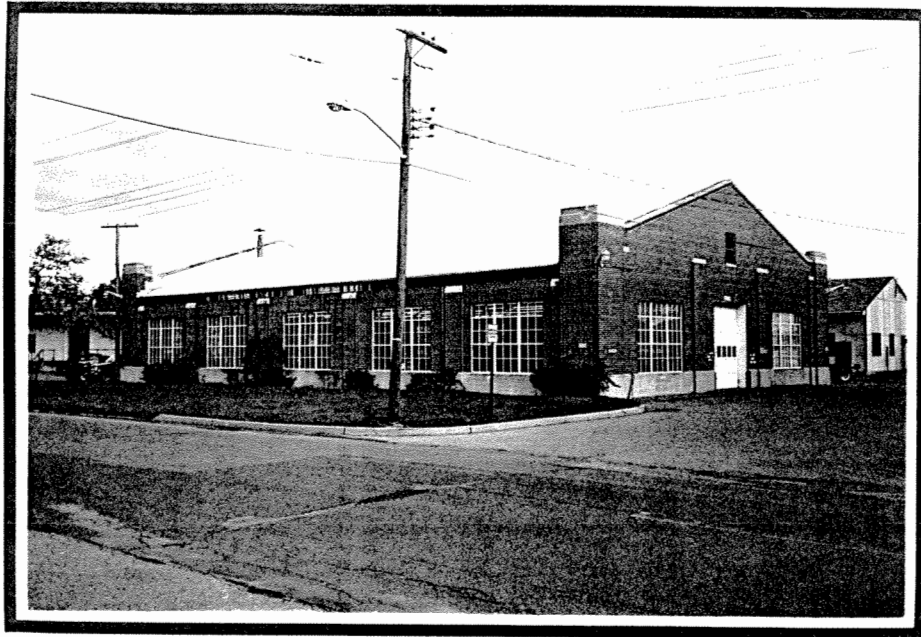
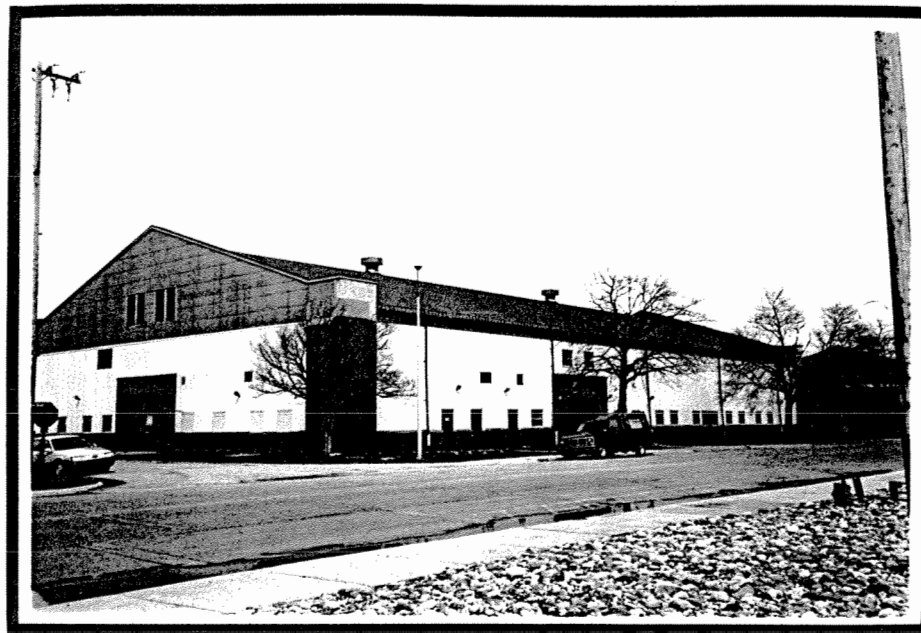
Figure III-51. 1934 Quatermaster garage (Building 279, Ft. Monmouth, New Jersey), *above*. 1932 Army Air Corps repair shop, with subsequent modifications covering original window openings (Building 117, Selfridge ANG, Michigan), *below*.

The functions of Quartermaster shops evolved between the late nineteenth century and the end of the 1930s. By the turn-of-the-century, railroads had replaced wagon trains and wheelwrights were no longer needed. During the inter-war period, the Army began to use trucks to transport supplies. The construction of blacksmith shops and quartermaster garages illustrates that both horses and motorized vehicles had roles on Army posts during the 1930s (Figures II-50 and III-51).

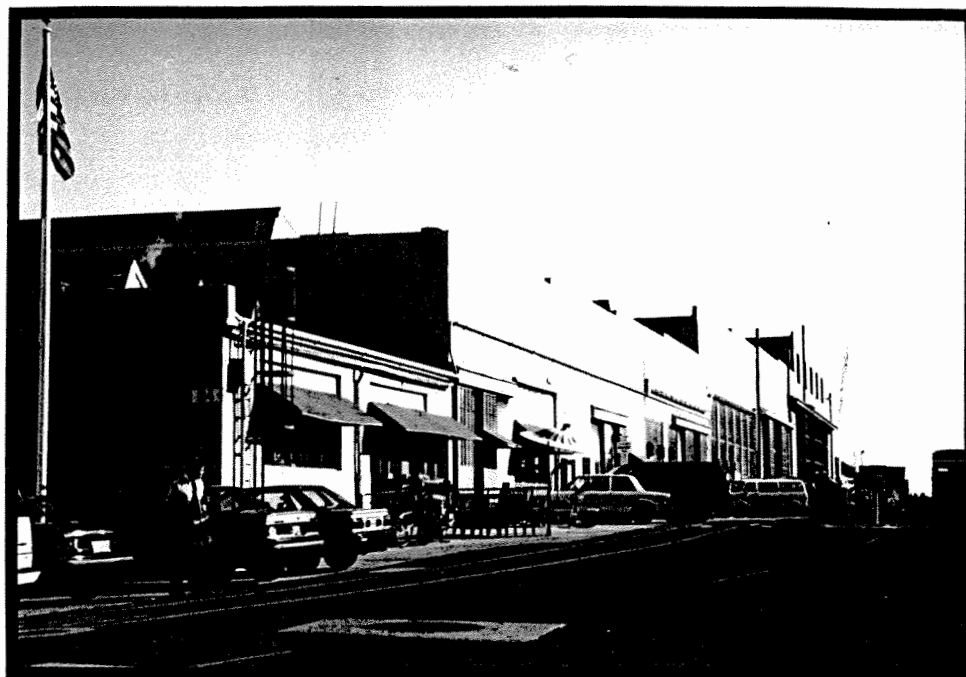
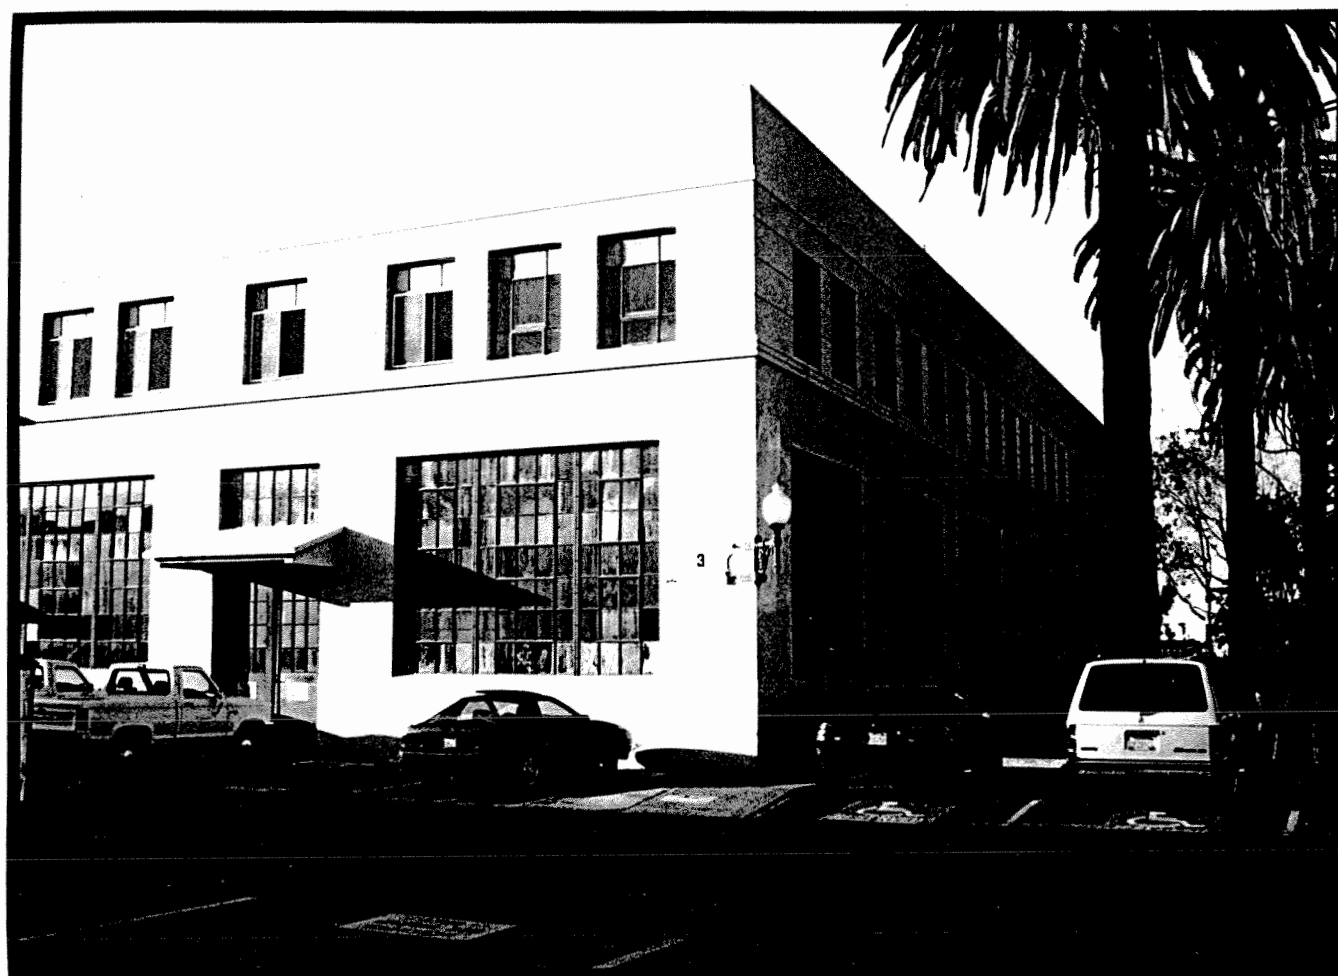
Figure III-52. ca. 1935 Final Engine Overhaul and Assembly Shop (Building 94, Naval Air Station North Island, California), *above*. 1919 Shops and Tool Room (Building 3, Naval Air Station North Island, California), *below*.

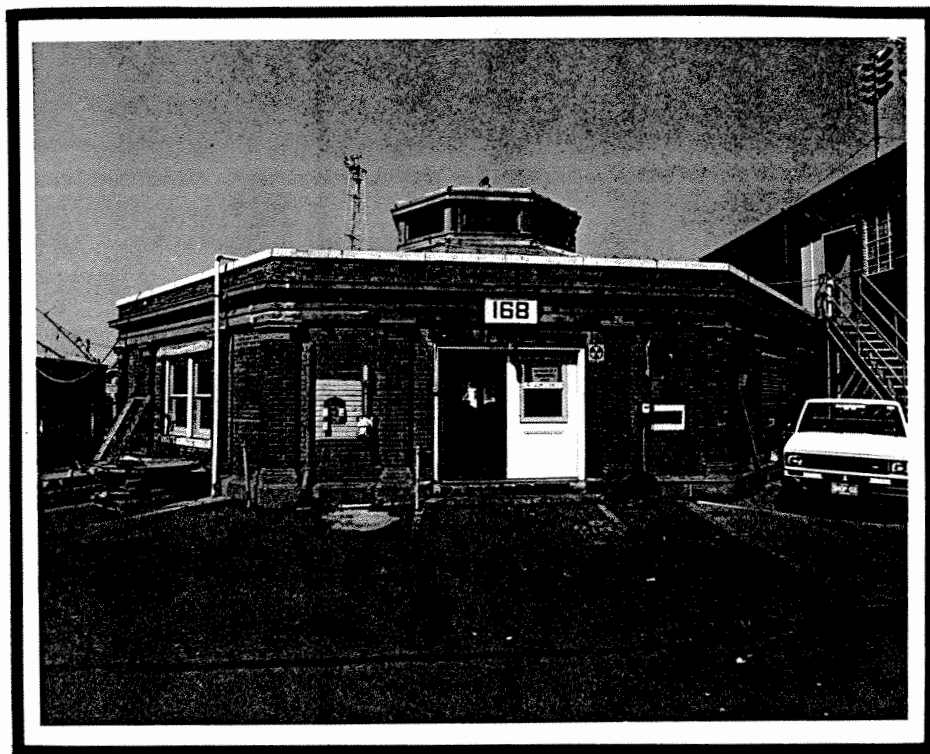
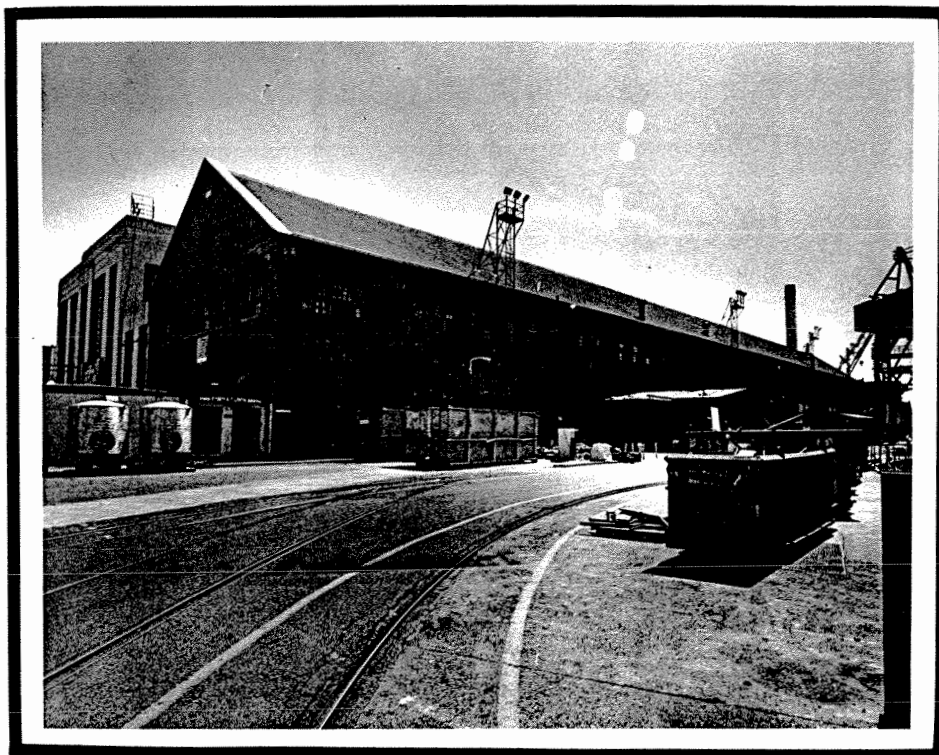
Figure III-58. 1908 Pumphouse (Building 168, Naval Shipyard Puget Sound, Bremerton, Washington), *above*. 1898 Machine shop, constructed of brick-encased steel frame (Building 58, Naval Shipyard Puget Sound, Bremerton, Washington), *below*. (Courtesy U.S. Navy)

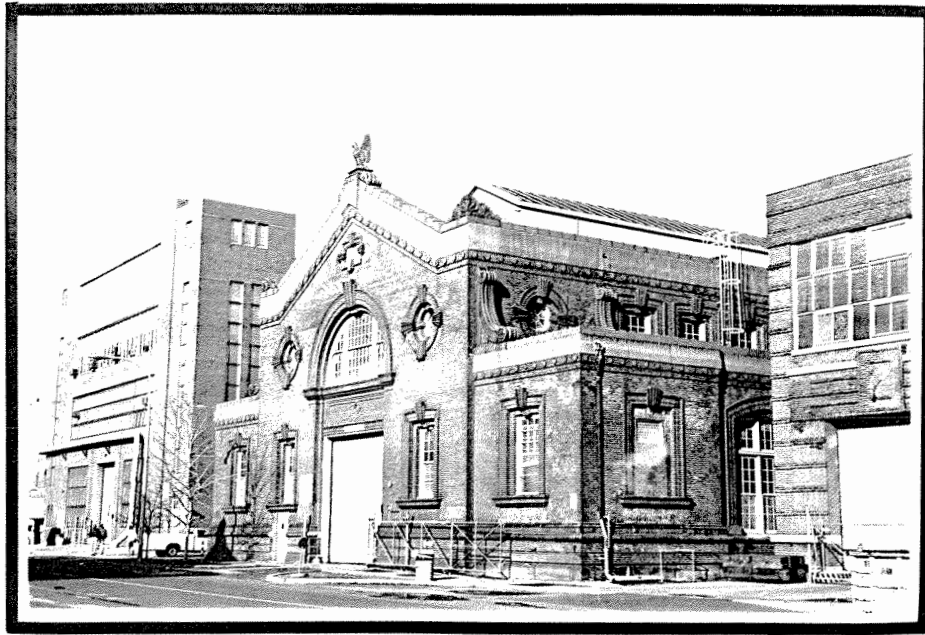
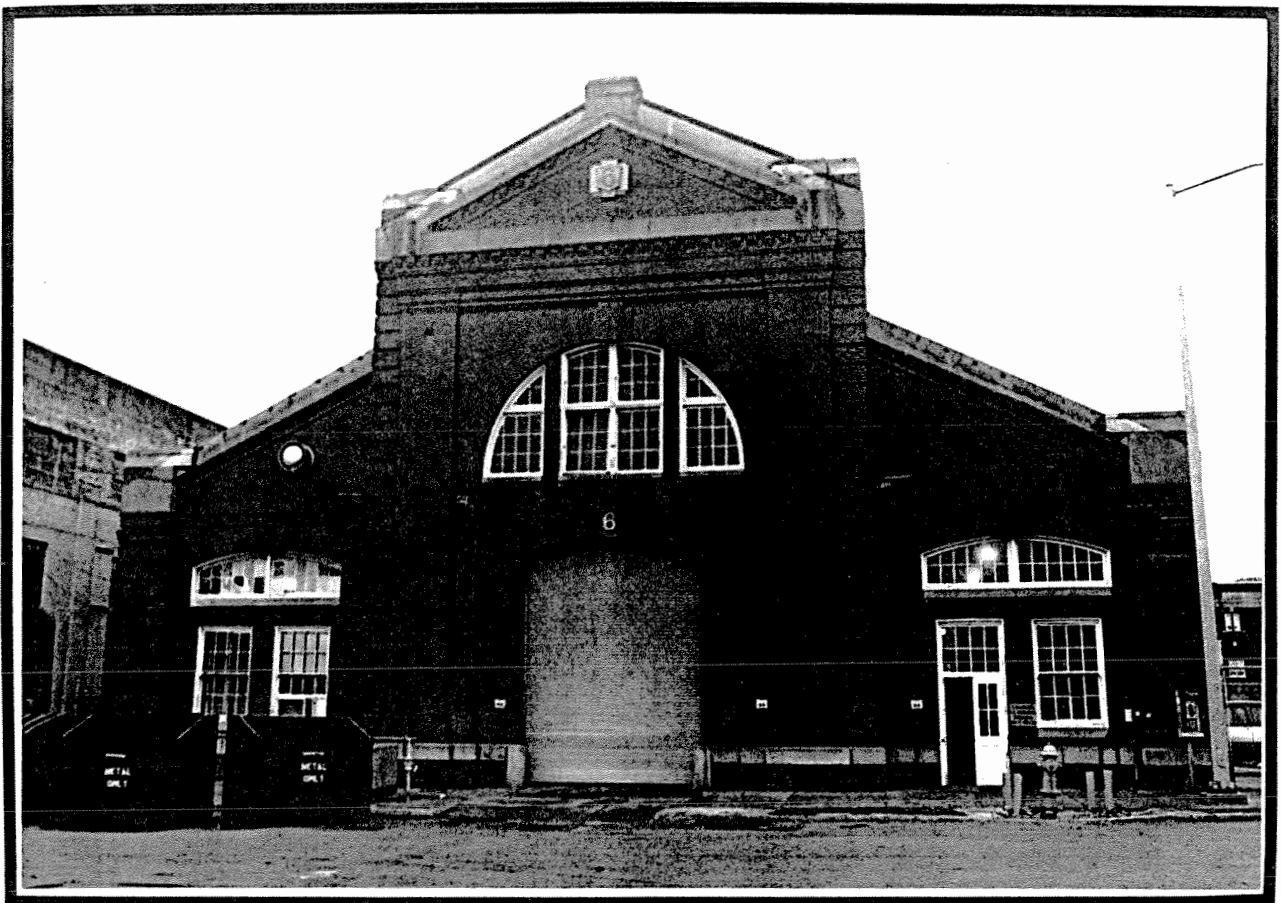
Figure III-59. 1905 Foundry (Building 17, Philadelphia Naval Base, Pennsylvania), *above*. 1906 Foundry and blacksmith shop (Building 6, Naval Base Charleston, South Carolina), *below*.

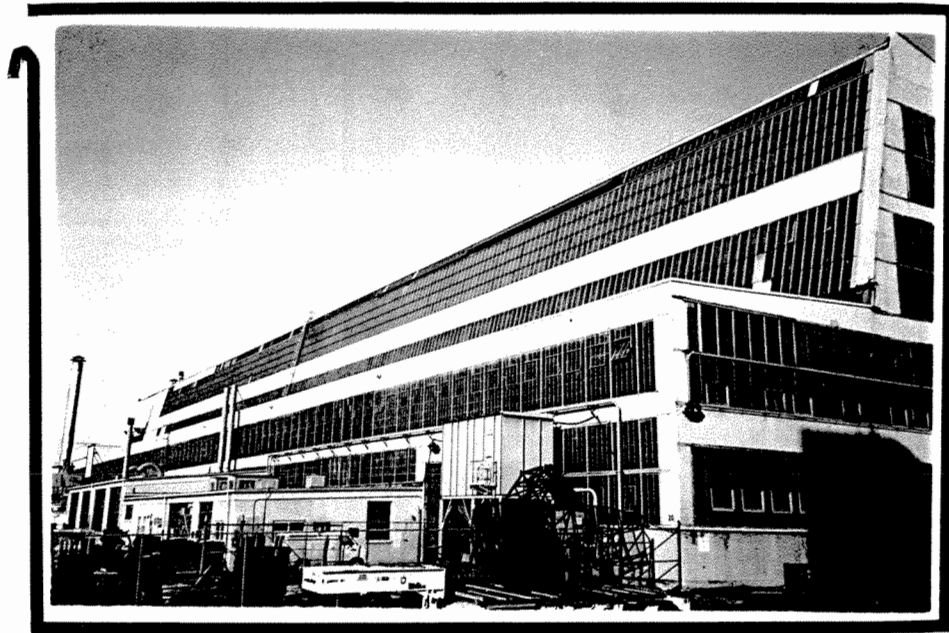
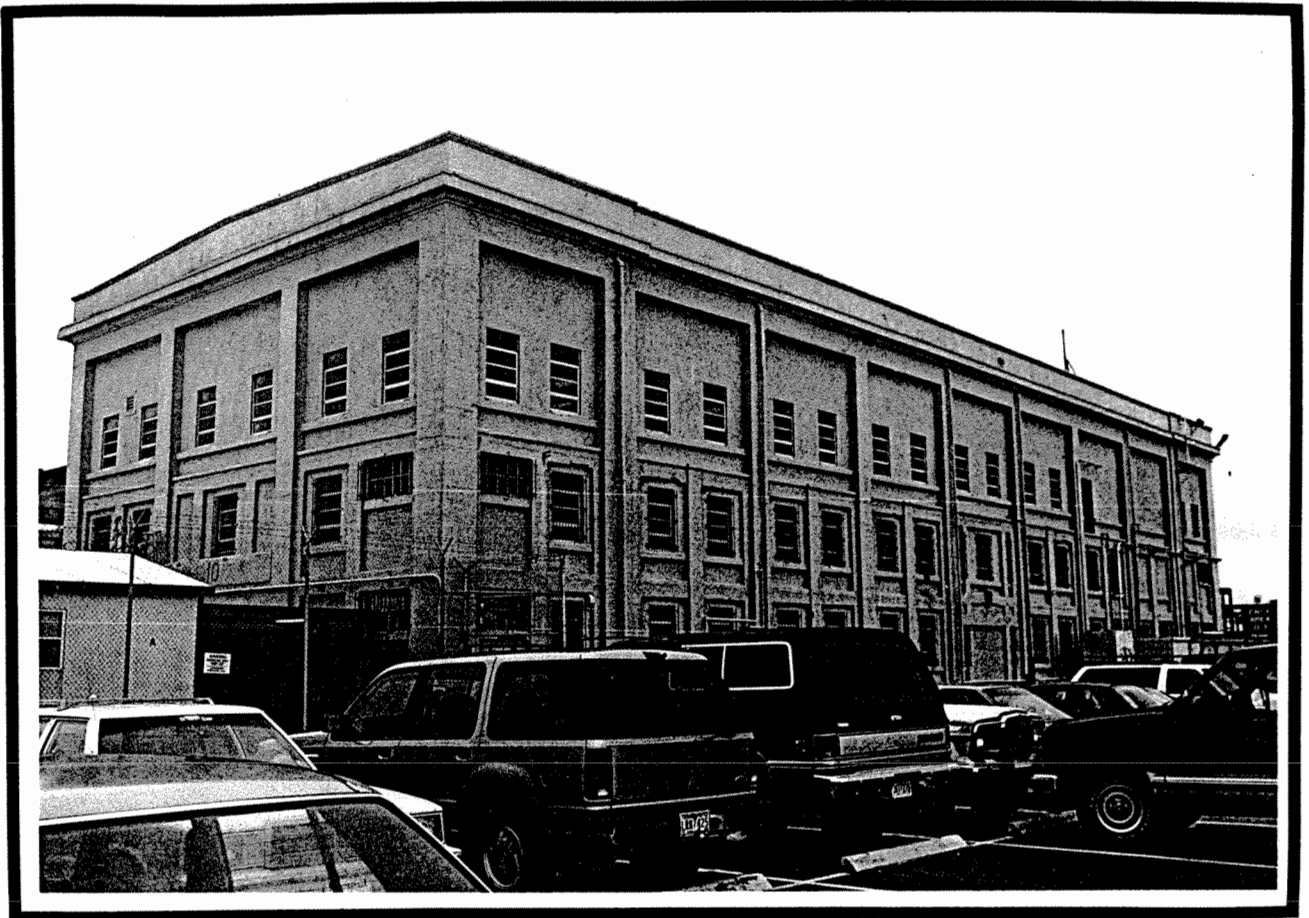
Figure III-60. 1919 Foundry (Building 20, Philadelphia Naval Base, Pennsylvania),
above. 1918 Pattern shop (Building 10, Naval Base Charleston,
South Carolina), below

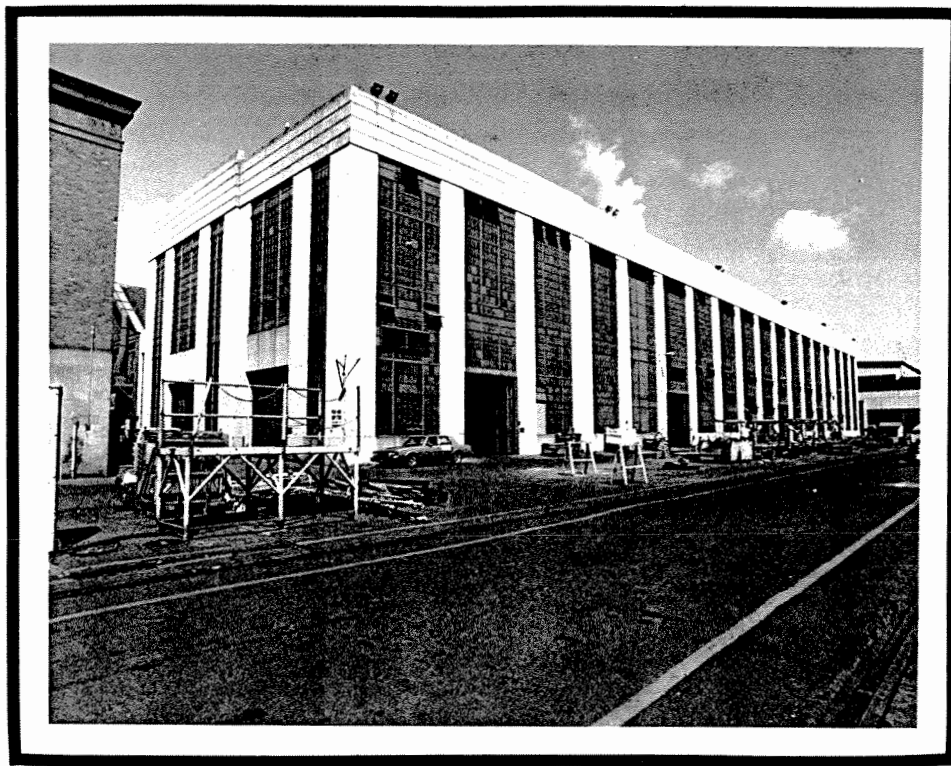
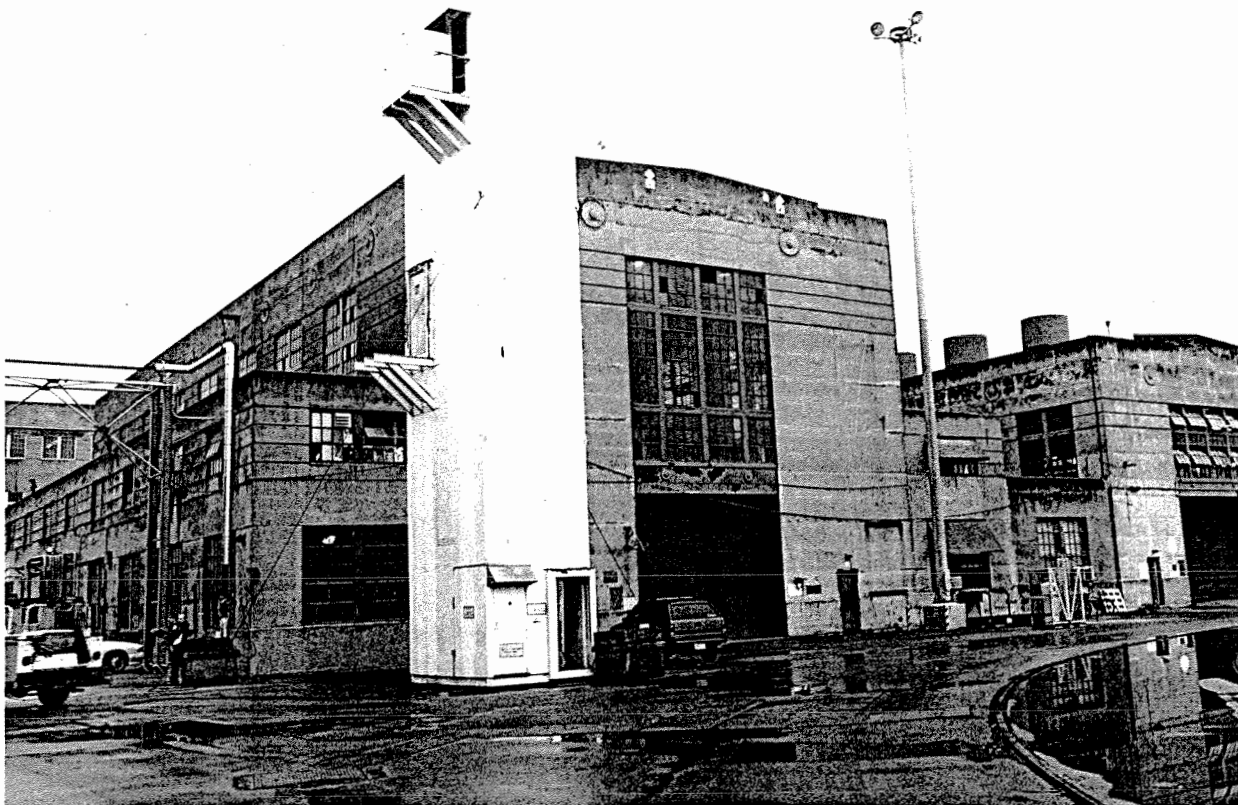
Figure III-61. 1938-1939 Forge shop (Building 452, Naval Shipyard Puget Sound, Bremerton, Washington), *above*. 1937 Pipe and copper shops (Building 56, Naval Base Charleston, South Carolina), *below*. (Courtesy U.S. Navy)

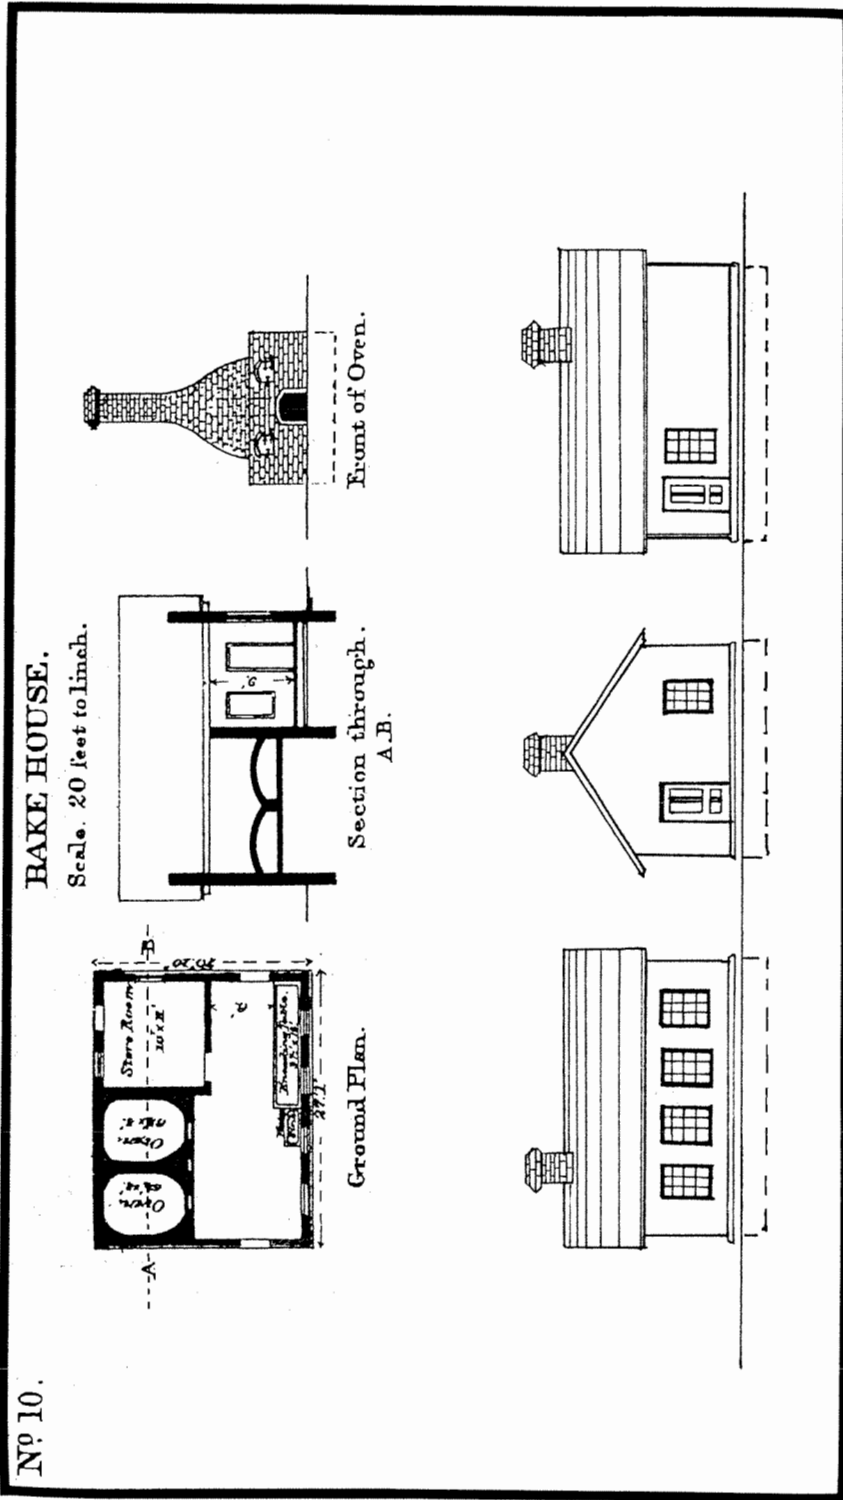
Figure III-62. 1872 Quartermaster bakery plan. (From War Department. *Annual Quartermaster Report*. Washington, D.C.: Government Printing Office, 1872.)

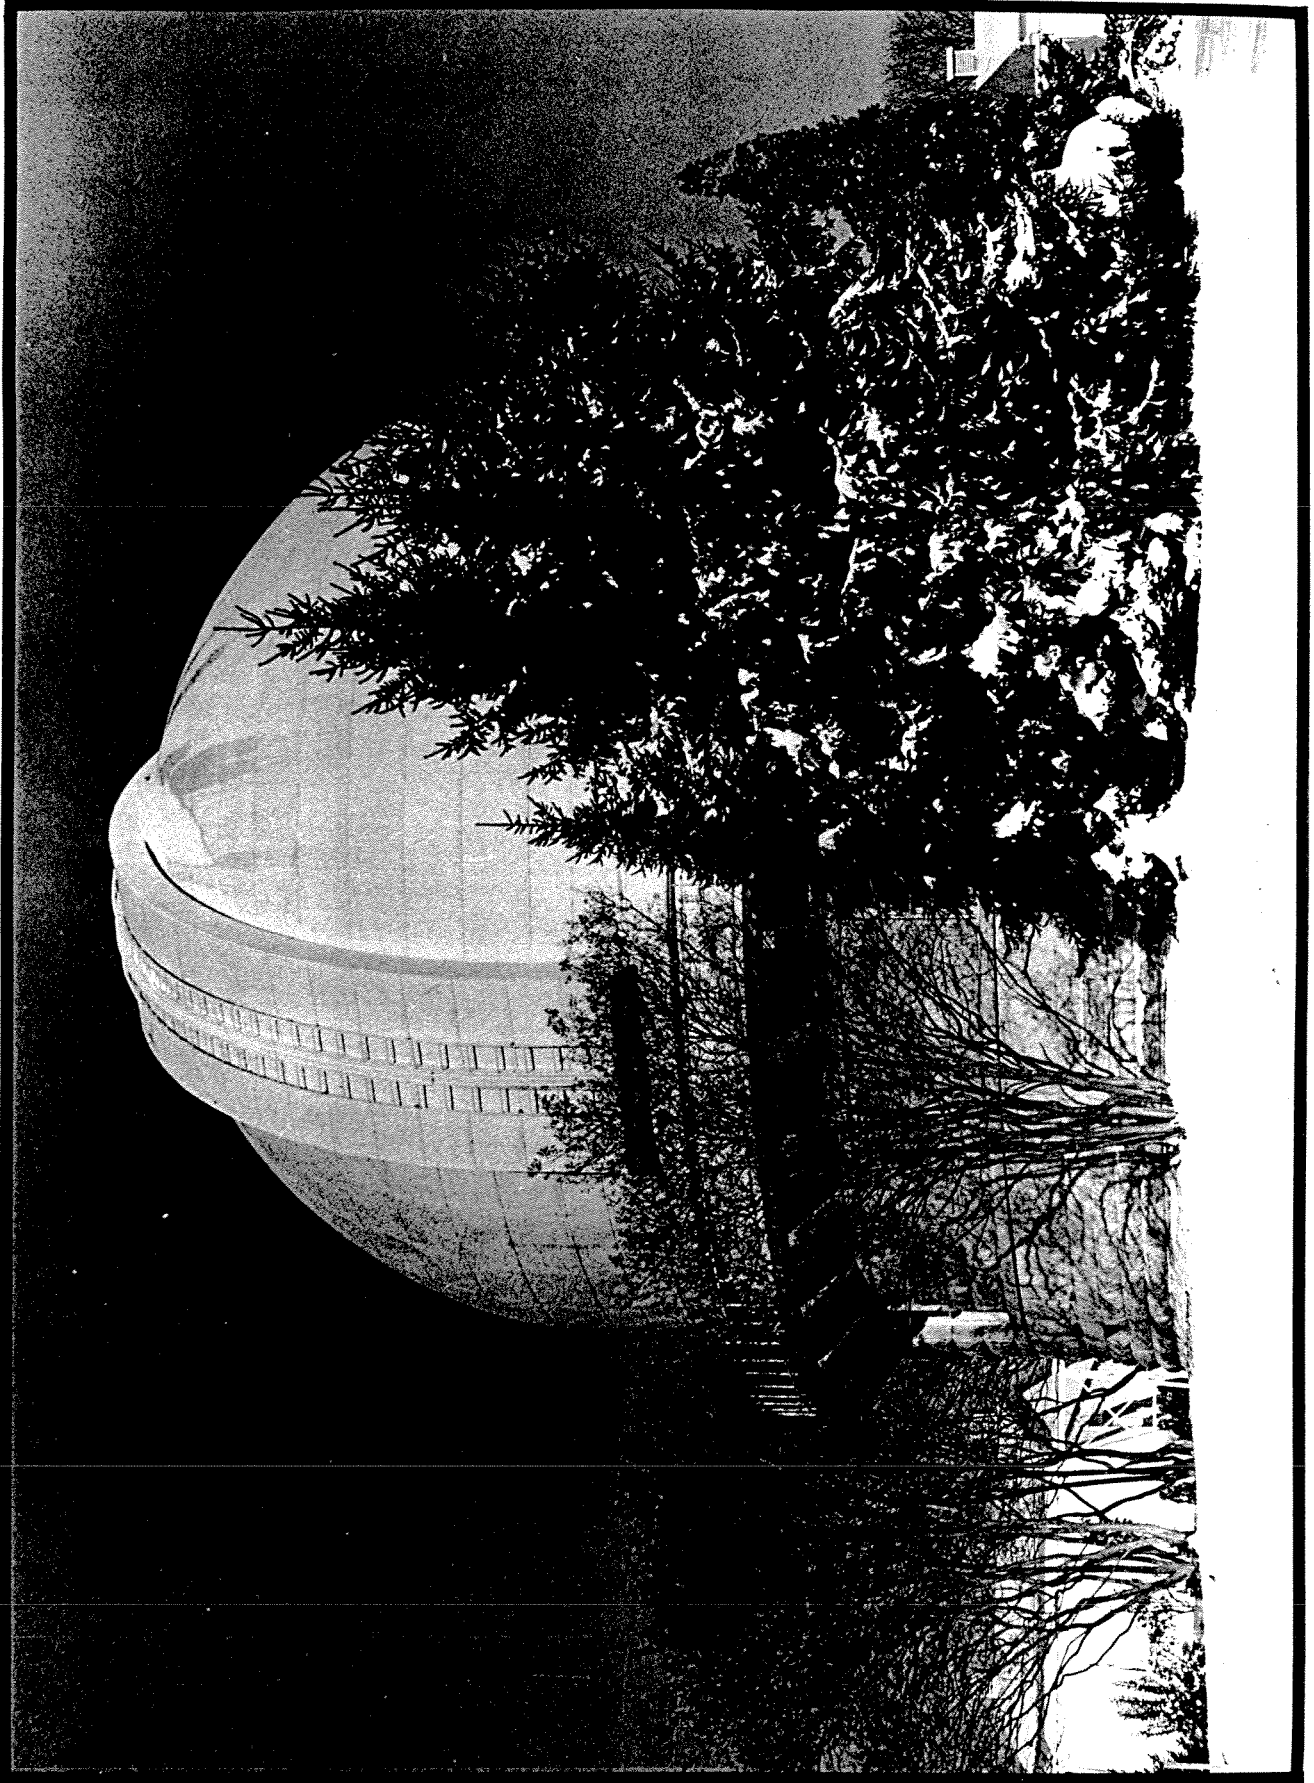
Figure III-103. 26-inch telescope dome constructed during 1890s (Naval Observatory, Washington, D.C.).

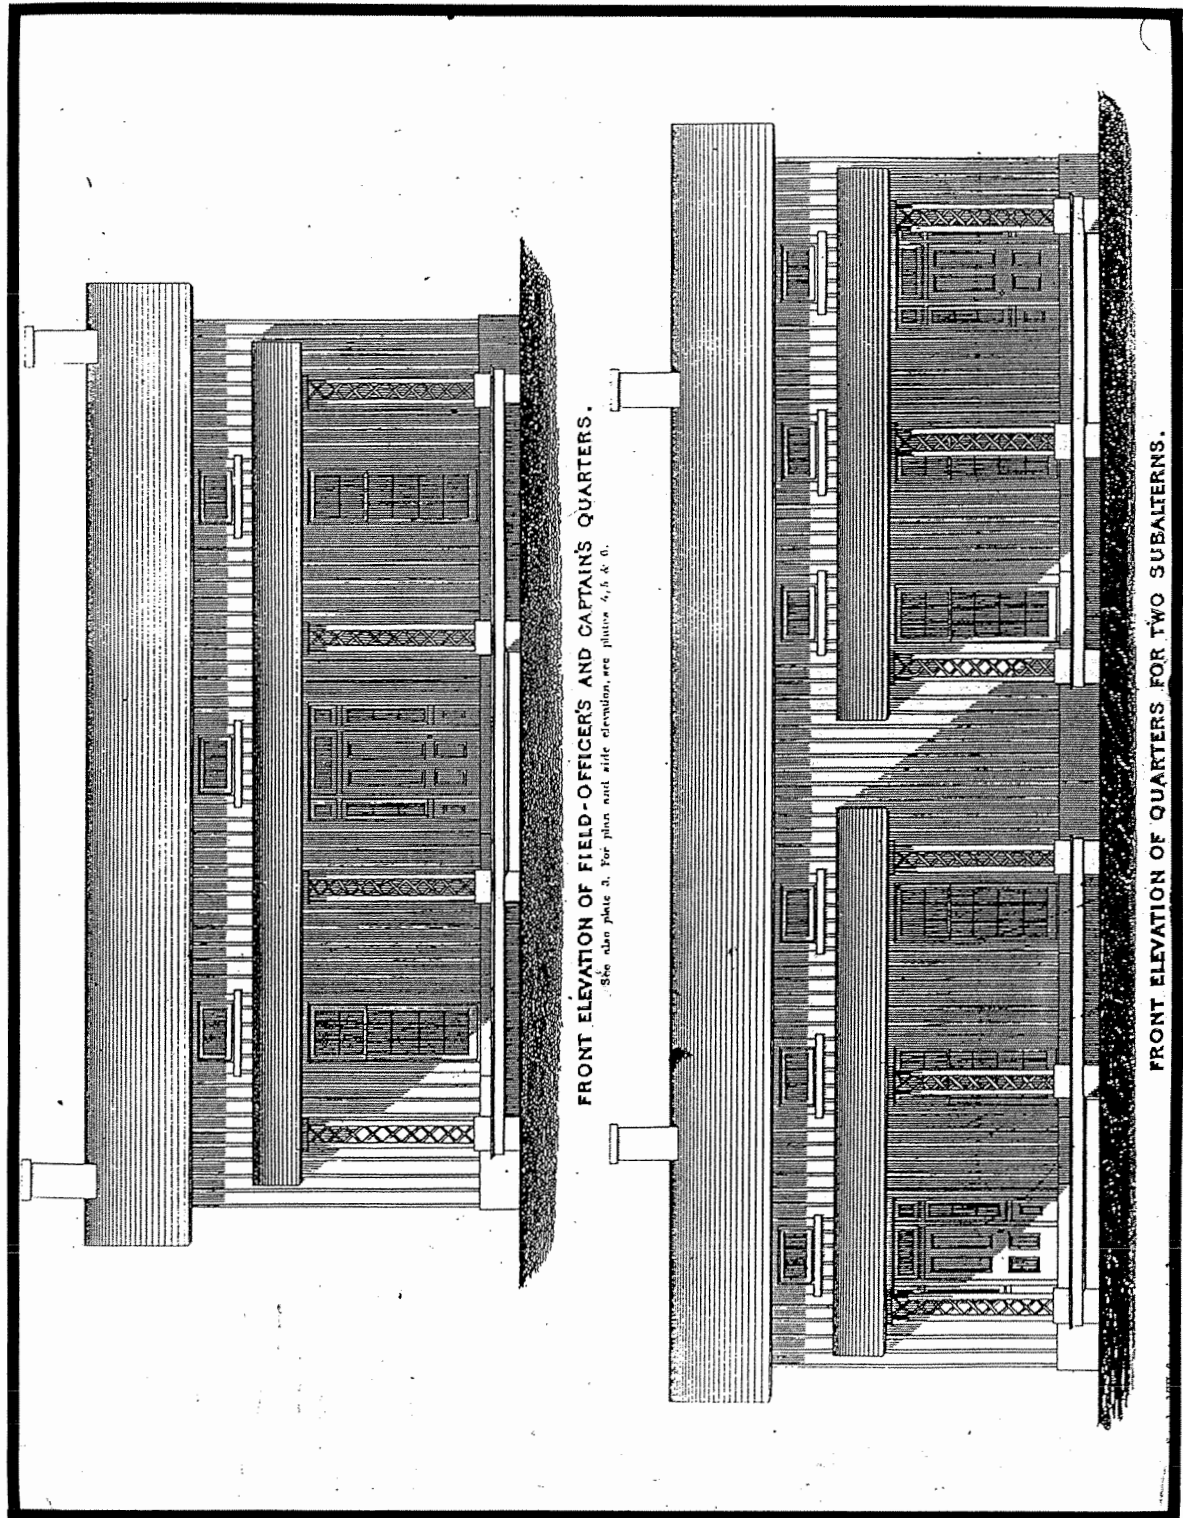
Figure III-130. Proposed 1860 plans for officers quarters. From *Regulations Concerning Barracks and Quarters for the Army of the United States 1860*. Washington, D.C.: George W. Bowman, 1861

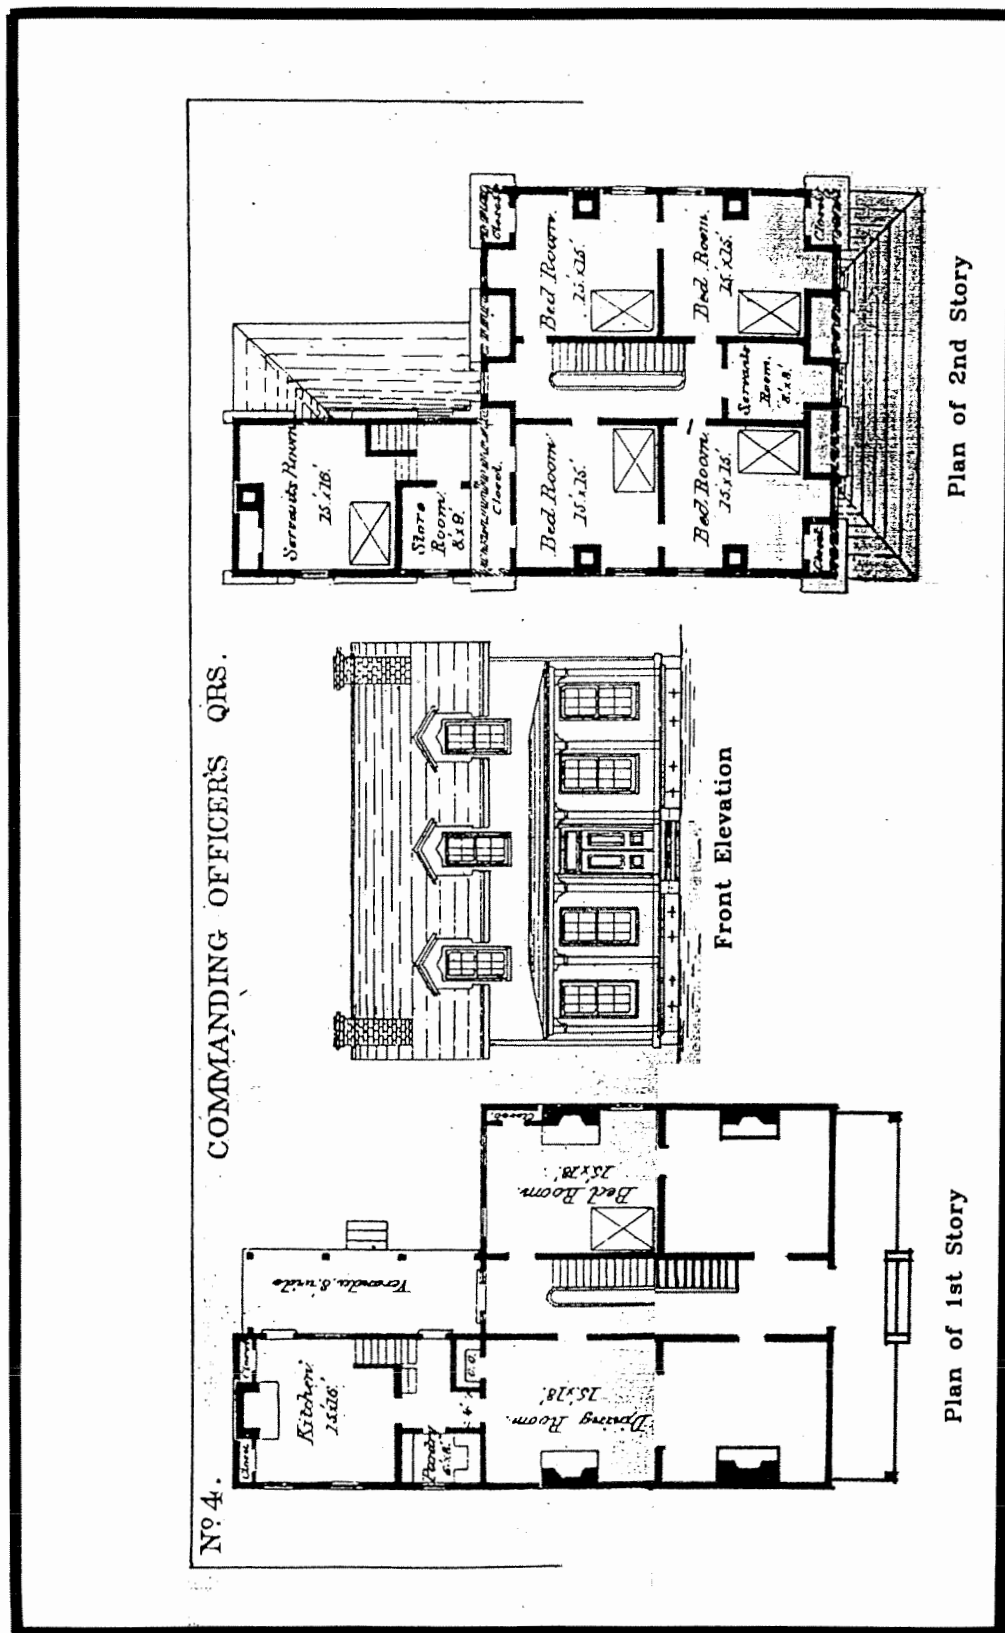
Figure III-132. Proposed 1872 Quartermaster plans for commanding officer quarters. (From War Department. *Annual Quartermaster Report*. Washington, D.C.: Government Printing Office, 1872.)

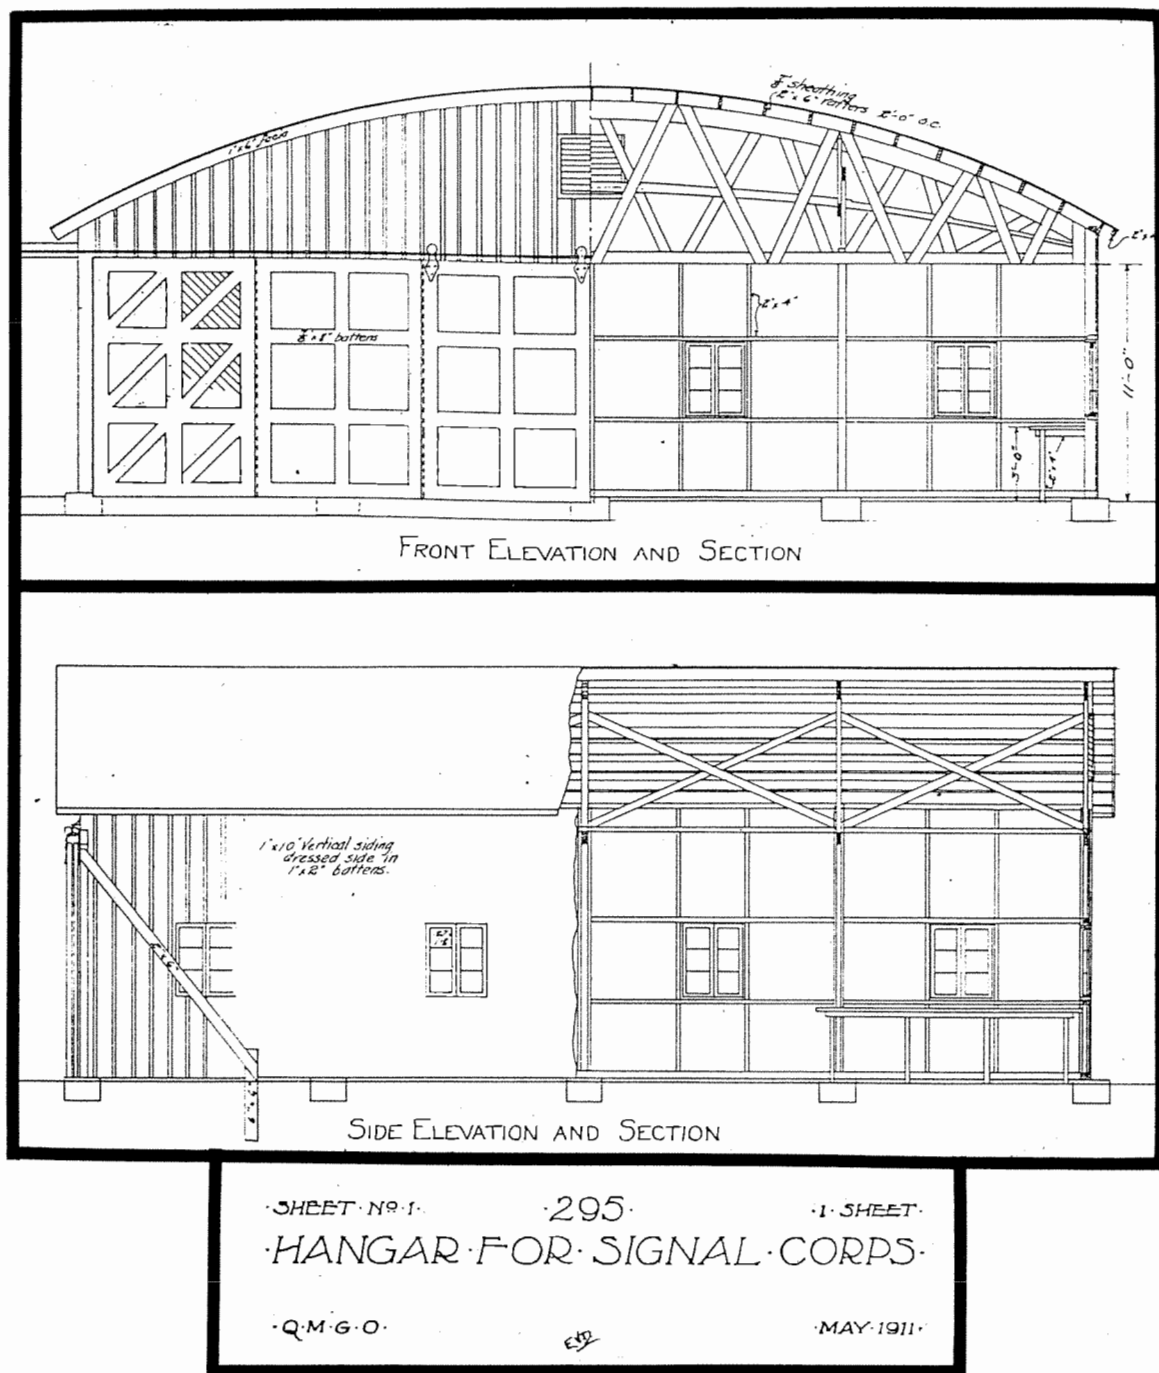
Figure III-157. Quartermaster standardized plan no. 295 for Signal Corps hangar. (From National Archives, Cartographic Branch, Record Group 77, Records of the Chief of Engineers, Standard Plans of Army Post Buildings 1891-1918.)
